### Post-fire behaviour of continuous reinforced concrete slabs under different fire conditions

# Post-fire behaviour of continuous reinforced concrete slabs under different fire conditions

**Abstract:** An experimental investigation of the performance of reinforced concrete continuous slabs is presented in this paper, following the exposure of the slabs to different compartment fires. The influence that several factors, including compartment fire scenarios, reinforcement ratio, and bar arrangement, have on the deflections, strains, crack patterns, and failure modes is analysed. Results that compared to the uniform fire case, localized or extended punching shear failure modes are more likely to occur in the fire-damaged slabs subjected to the traveling fire due to more cracks. The residual structural stiffness and ultimate loads are enhanced with the increasing reinforcing ratio, but the brittle punching failure readily appeared. Finally, the deflection failure criterion ( $l/50$ ) and the ACI 318-08 punching shear theory are helpful in predicting the residual ultimate loads of the fire-damaged slabs subjected to any fire scenario.

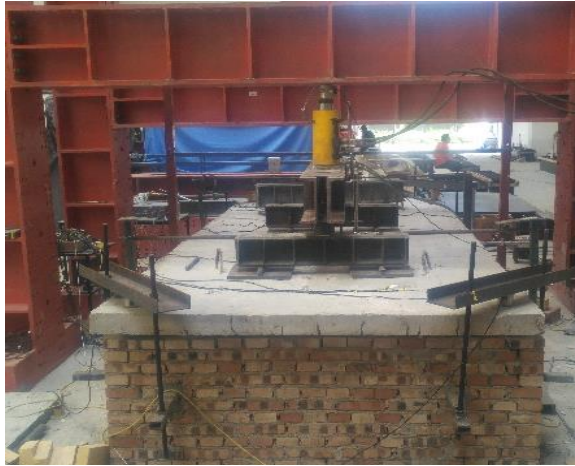
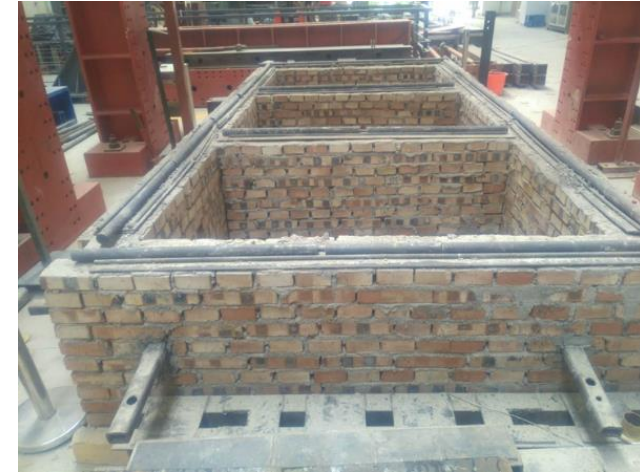
**Fig. 2.** Details of the test setup (all dimensions in mm): (a) Photograph of the test setup; (b) Photograph of the support; (c) Plan view of the test setup; (d) Cross section 1-1 of test setup

After the fire tests all four slabs were moved from the furnace and stored in the structural lab for approximately 3 months. Then the fire-damaged slabs were tested on the new test rig, as shown in Fig. 2. For the residual tests, the fire-damaged slabs were renamed as Slabs B1-PF to B4-PF for Slabs B1 to B4.

As indicated in Fig. 2(c), each corner of the slab was held down by a steel beam. The reaction forces at the corners were measured by four pressure transducers (Points P-1 to P-4). The failure of a slab was governed by: 1) conventional mid-span deflection failure criterion; 2) concrete crushing on the top surface; and 3) punching shear failure. Once any one of those failure conditions was reached, the test was terminated.

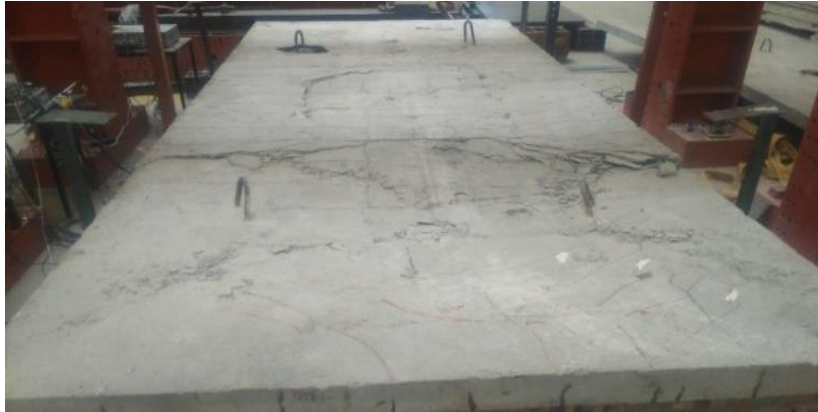
**Fig. 7** Failure modes of Slab B2-PF (all dimensions in mm): (a) Photograph of cracks on the top surface; (b) Crack pattern on the top surface; (c) Photograph of cracks on the bottom surface; and (d) Crack pattern on the bottom surface

Figs. 7(a) and (b) show the crack patterns on the top surface of Slab B2-PF (steel spacing: 200 mm). During the residual test, before the loading reached 60 kN, many small arc cracks appeared on the top surface of Spans A and C. As the load increased, the arc cracks gradually widened. At approximately 210 kN, a punching shear failure of Span C occurred with one hole. Furthermore, the concrete crushing (maximum concrete strain: 3386  $\mu\epsilon$ ) on the top surface of Span A suddenly occurred as well as the steel yielding (reinforcement strain: exceeded 10000  $\mu\epsilon$ ), as discussed later. Thus, compared to Slab B1-PF, the structural stiffness of Slab B2-PF was larger, owing to the shorter fire duration and fewer original cross cracks (smaller fire time delay, i.e., 30 min). This observation also implies that the fire scenarios have important effects on the failure mode of the middle span in the fire-damaged slab, as they can lead to different cracks or spalling during the heating stage [27].

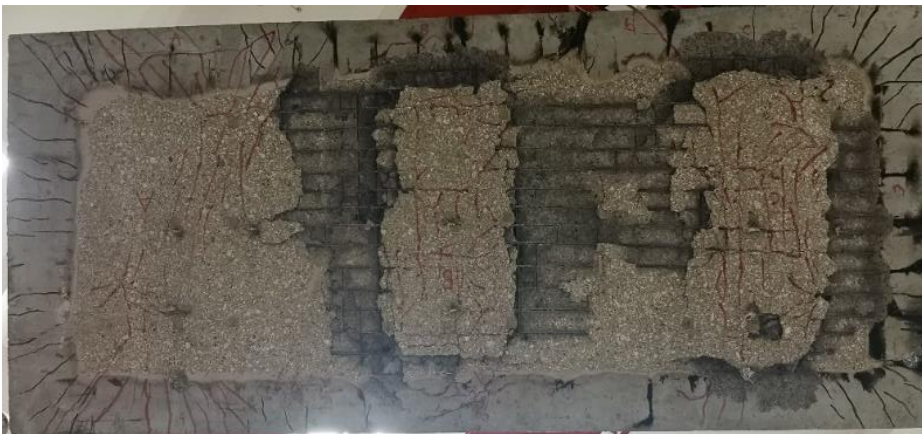
**Fig. 8** Failure modes of Slab B3-PF (all dimensions in mm): (a) Photograph of cracks on the top surface; (b) Crack pattern on the top surface; (c) Photograph of cracks on the bottom surface; and (d) Crack pattern on the bottom surface

Figs. 8(a) and (b) show the crack pattern on the top surface of Slab B3-PF (steel spacing: 100 mm). Due to many small original cracks in Spans B and C, punching shear failure occurred with four holes on the top surface and smaller vertical deflections. These punching shear areas appeared around the loading plate on the top surface.

ratio led to more small and tiny original cracks [27], indicating that the bond between the concrete and steel was seriously compromised. In addition, owing to fewer original cracks in Span A, the flexural failure modes occurred, such as new corner and arc cracks. Thus, the failure mode indicated that the fire-damaged slabs with higher reinforcement ratios had a higher residual bearing capacity, but the punching shear failure easily occurred because of numerous small original cracks (negative moment). Compared to Slabs B1-PF and B2-PF, the original crack width on the top surface of Slab B3-PF was much smaller due to the smaller steel spacing (100 mm). The comparison indicates that the residual property of the steel has a large effect on the flexural carrying capacities; however, the residual property of the concrete, original crack patterns (particularly crack spacing), and load type (concentrated load) have a greater effect on the failure mode.

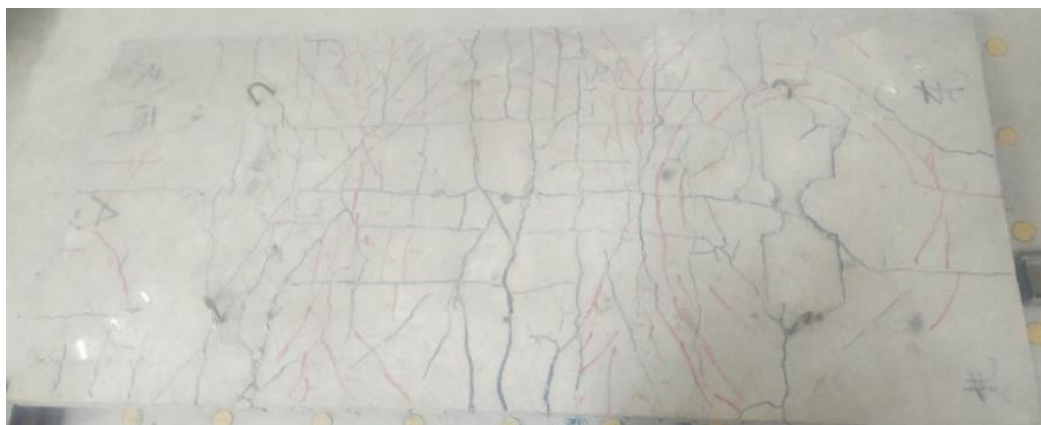
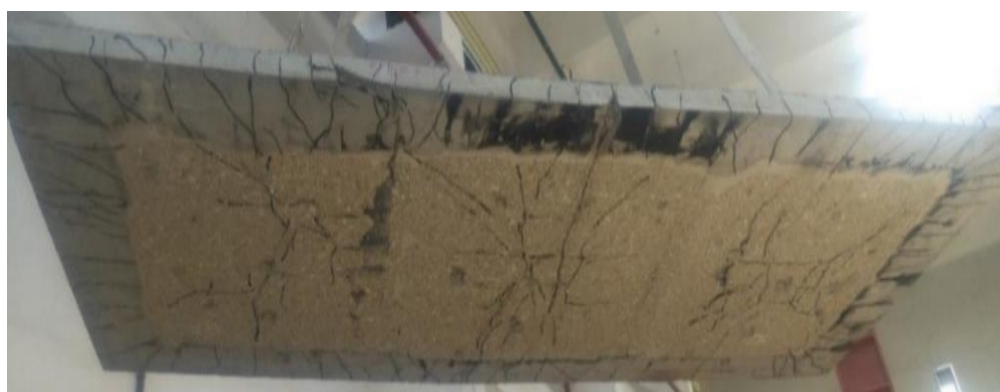
**Fig. 9** Failure modes of Slab B4-PF (all dimensions in mm): (a) Photograph of crack on the top surface; (b) Crack pattern on the top surface; (c) Photograph of cracks on the bottom surface; and (d) Crack pattern on the bottom surface

Figs. 9(a) and (b) show the crack pattern on the top surface of Slab B4-PF (steel spacing: 200 mm). In contrast to the flexural failure (arc and flexural cracks) of Spans A and B, the punching shear failure of Span C occurred. In addition, like Slabs S1-PF and S2-PF, the bottom concrete in Slab B4-PF did not fall off, as shown in Figs. 9(c) and (d). However, due to the negative reinforcement layout, the bearing capacity (120 kN) of Slab B4-PF was the smallest. The comparison further indicates that the reinforcement ratio and reinforcement layout have a significant effect on the bearing capacity of the fire-damaged slabs. Hence, the beneficial or detrimental effects of the reinforcement ratio (layout) should be considered in the residual property judgement of post-fire continuous slabs.
